NONSTRUCTURAL FLOOD RISK MANAMAGEMENT ASSESSMENT

US Army Corps
of Engineers
Huntington District

Virginia Silver Jackets
FINAL
December 2020

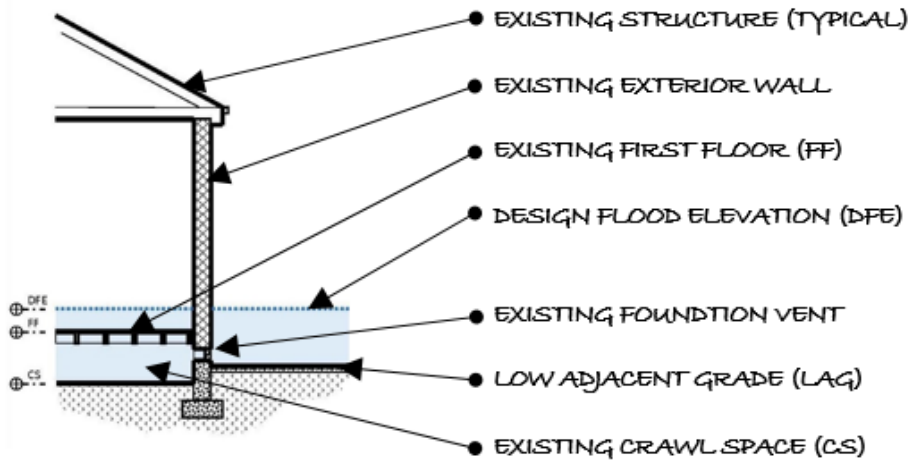
DIAGRAMMATIC WALL SECTION (EXISTING STRUCTURE)

- First floor 1.30 ft. below DFE
- Crawlspace 4.30 ft. below DFE
- Exterior HVAC units at grade

Structure/Flood Elevations Table (all elevations in ft.)						
LAG	FF	CS	DFE	Δ DFE- LAG	Δ DFE-FF	Δ DFE-CS
1915.60'	1918.00'	1915.00'	1919.30'	3.70'	1.30'	4.30'
ABBREVIATIONS: FF – First Floor Elevation; LAG – Low Adjacent Grade Elevation; BF – Basement Floor Elevation; CS – Crawl Space Ground Elevation; DFE – Design Flood Elevation; Δ – Delta (Elevation Difference); NA – Not Applicable; * - Estimated

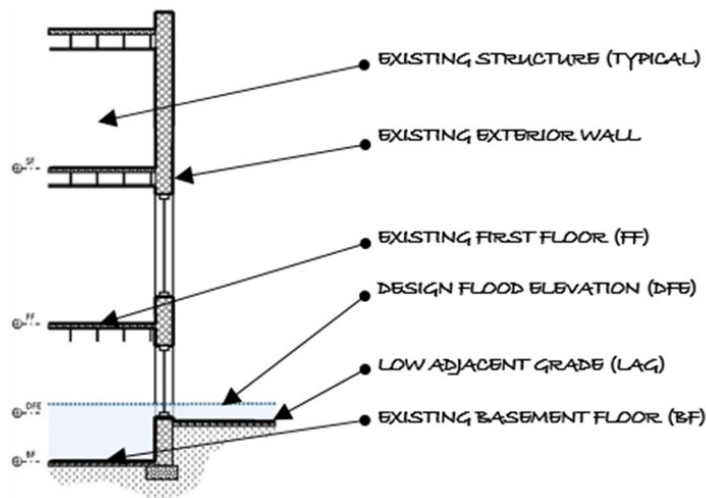
DIAGRAMMATIC WALL SECTION (EXISTING STRUCTURE)
 NOT TO SCALE

- First Floor 6.10 ft. above DFE
- Basement 4.40 ft. below DFE
- Exterior HVAC units at grade (rear/side). Interior systems are in the basement. HVAC to be rehabbed and new equipment moved to a higher level.

Structure/Flood Elevations Table (all elevations in ft.)*						
LAG	FF	BF	DFE	Δ DFE-LAG	Δ DFE-FF	Δ DFE-BF
1914.50'	1922.10'	1911.60'	1916.00'	1.50'	(6.10')	4.40'
ABBREVIATIONS: FF – First Floor Elevation; LAG – Low Adjacent Grade Elevation; BF – Basement Floor Elevation; CS – Crawl Space Ground Elevation; DFE – Design Flood Elevation; Δ – Delta (Elevation Difference); NA – Not Applicable; * - Estimated

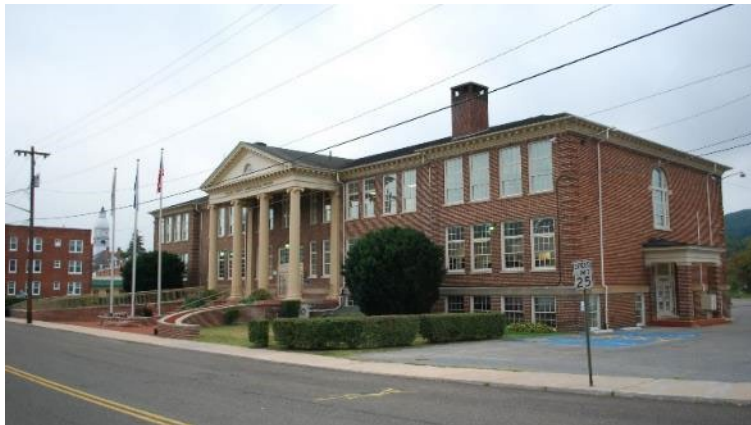
Front (North) Elevation

The structure is located at the northwest edge of the downtown commercial district, is free standing and fronts Third Street NW. County offices occupy the structure. The structure is within the boundaries of FEMA's 1% regulatory flood plain.

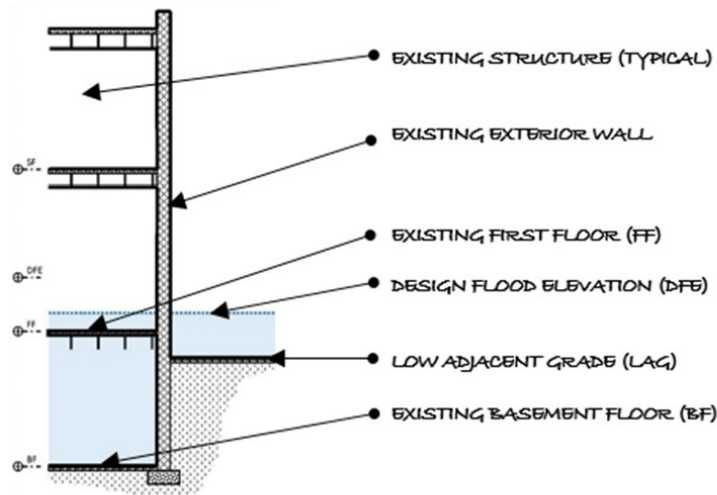
DIAGRAMMATIC WALL SECTION (EXISTING STRUCTURE)
 NOT TO SCALE

- First Floor 1.50 ft. below DFE
- Basement 11.50ft. below DFE
- Exterior HVAC units are on the roof.
- Interior systems are in the basement.

Structure/Flood Elevations Table (all elevations in ft.)*						
LAG	FF	BF	DFE	Δ DFE-LAG	Δ DFE-FF	Δ DFE-BF
1911.00'	1913.50'	1903.50'	1915.00'	4.00'	1.50'	11.50'
ABBREVIATIONS: FF – First Floor Elevation; LAG – Low Adjacent Grade Elevation; BF – Basement Floor Elevation; CS – Crawl Space Ground Elevation; DFE – Design Flood Elevation; Δ – Delta (Elevation Difference); NA – Not Applicable; * - Estimated

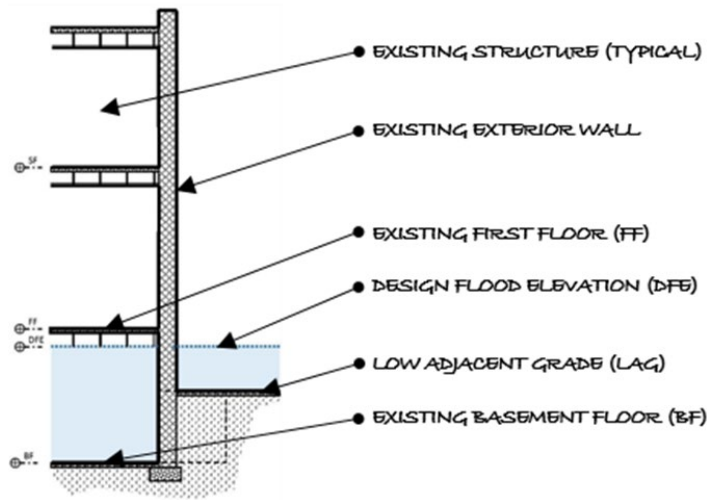
DIAGRAMMATIC WALL SECTION (EXISTING STRUCTURE)
NOT TO SCALE

Structure/Flood Elevations Table (all elevations in ft.)*						
LAG	FF	BF / CS	DFE	Δ DFE-LAG	Δ DFE-FF	Δ DFE-BF
1911.20'	1916.00'	1906.00'	1915.00'	3.80'	(1.00')	9.00'
