NONSTRUCTURAL FLOOD RISK MANAMAGEMENT ASSESSMENT

US Army Corps
of Engineers
Huntington District

Virginia Silver Jackets
FINAL
December 2020

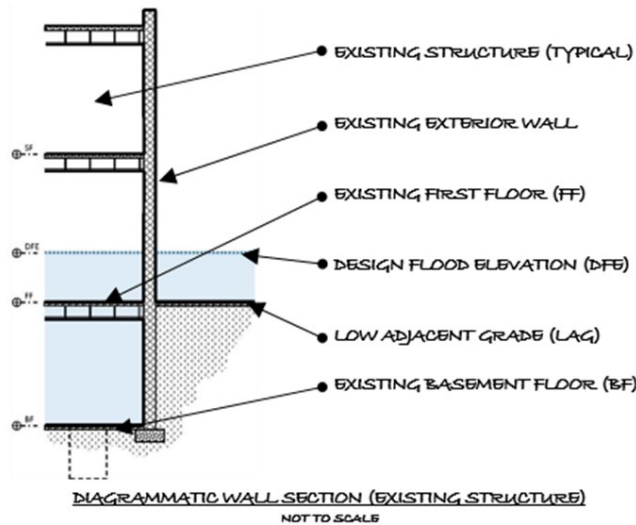
- First Floor 4 ft. below DFE
- Partial Basement 12 ft. below DFE
- Location of new HVAC units were not observed because of the building renovation.
- The Electric panels were located in the basement.

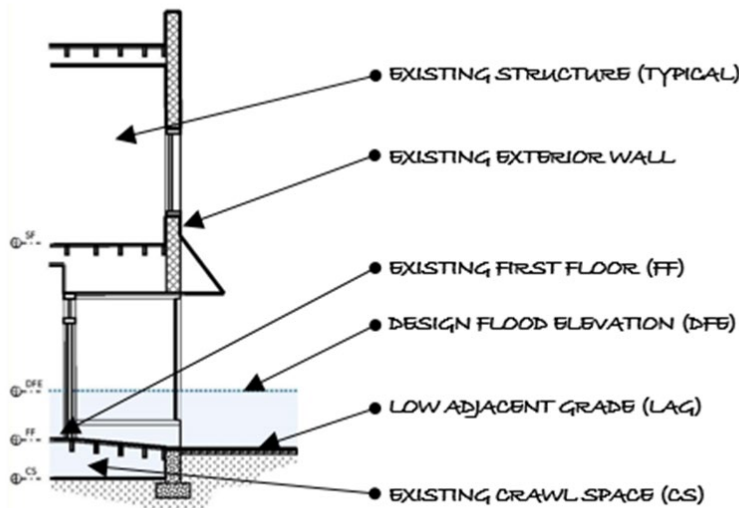
DIAGRAMMATIC WALL SECTION (EXISTING STRUCTURE)
NOT TO SCALE

- First Flood is 3.10 ft. below DFE
- Crawlspace is 5.10 ft. below DFE
- Building systems and utilities were not observed.

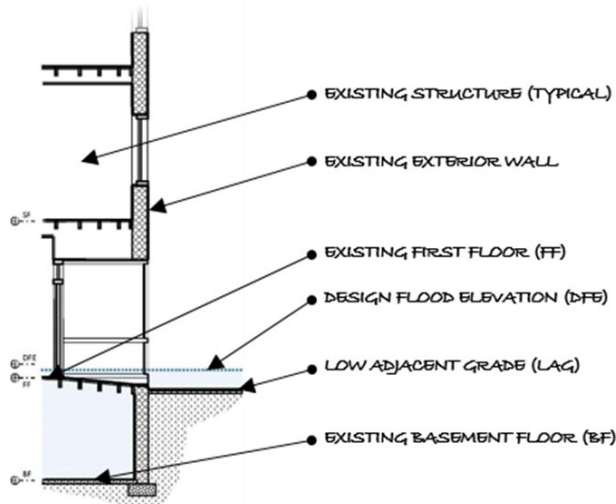
DIAGRAMMATIC WALL SECTION (EXISTING STRUCTURE)
NOT TO SCALE

- First Floor 1.10 ft. below DFE
- Basement floor 11.10 ft. below DFE
- Building systems and utilities were not observed.
- Basement floor is dirt

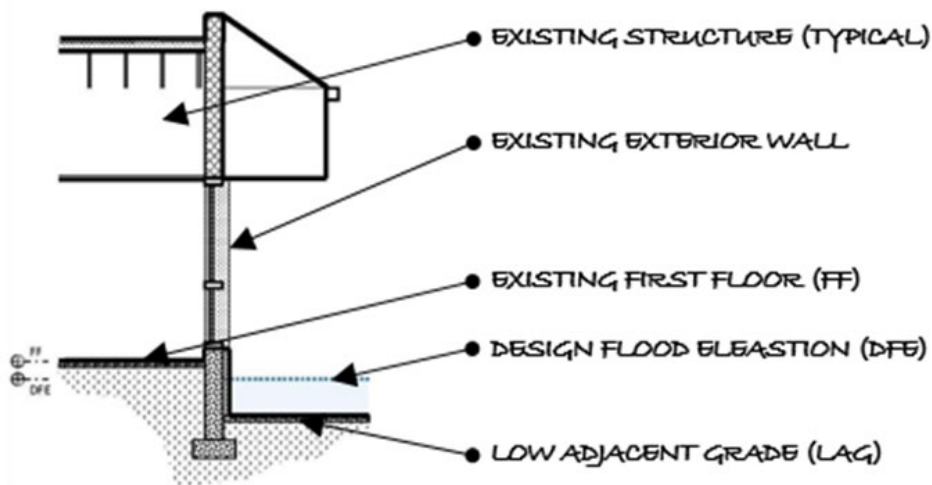
DIAGRAMMATIC WALL SECTION (EXISTING STRUCTURE)
NOT TO SCALE

- First floor 1 ft. above DFE
- Low Adjacent Grade 3 ft. below DFE
- Building systems and utilities were not observed.

Structure/Flood Elevations Table (all elevations in ft.)*						
LAG	FF	BF/CS	DFE	Δ DFE-LAG	Δ DFE-FF	Δ DFE-BF/CS
1912.50'	1916.50'	NA	1915.50'	3.00'	(1.00')	NA
